Manhole Inspection Summary

Manhole # S27I__052MH

Insp Date: **5/13/09 5:49 PM**

Location Address: **904 W. Lombard St**

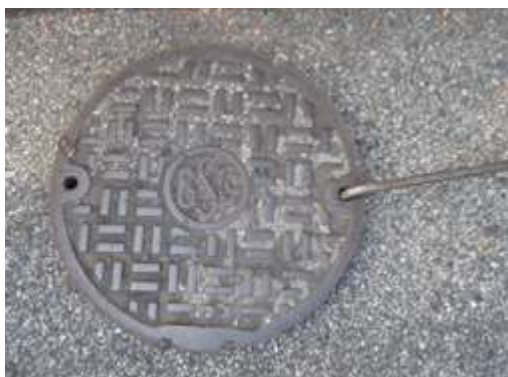
Miscellaneous

mh cover

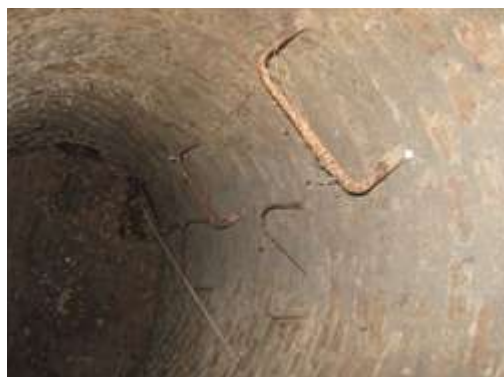
Defect 4

Count: **5** Missing: **2** ☒ **Corroded**

missing/corroded rungs

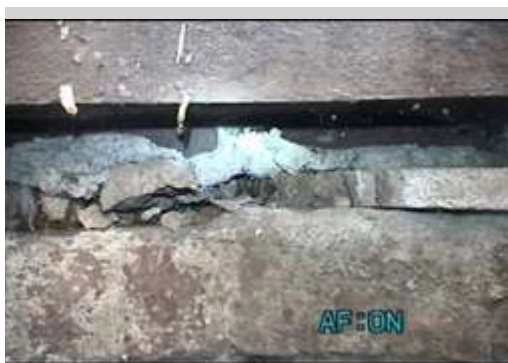
Defect 2

Condition: ☐ Sound ☐ Cracked ☐ Root Intrusion ☐ Loose Brick ☒ **Deteriorated**

deterioration under frame

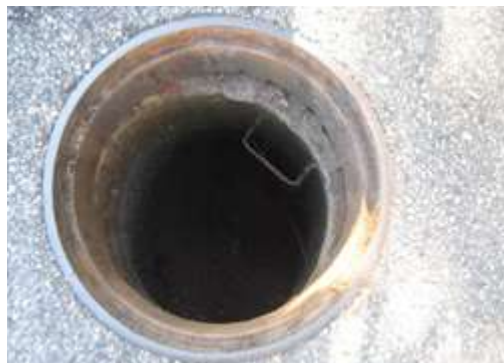
Defect 3

Offset: **2** (in.)

frame offset

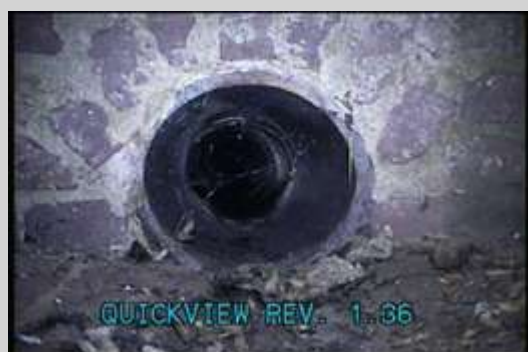
12 O'Clock Outflow

8 in. Circular Gravity Sewer
Pipe Out @ 12 O'Clock

Infiltration: **None** Pipe Seal Cond: **Sound**
